Using Dynamometer Data

Example 2: Worn Plunger – Worn Traveling Valve

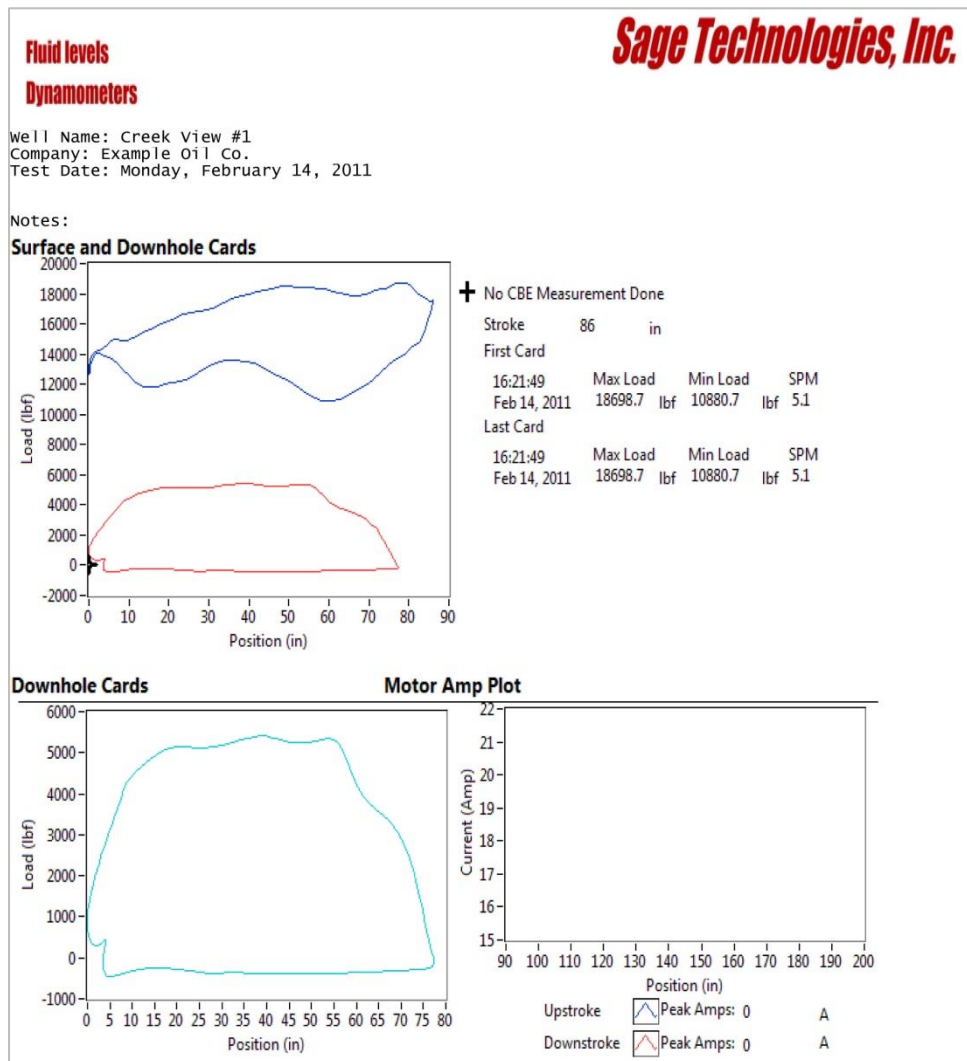
Well is running on Ajax gas engine. Fluid Level is shot and fluid found at 6231 ft.
 The high fluid level with such small current production is indicative of pump problems.
 A dynamometer is run on the well.

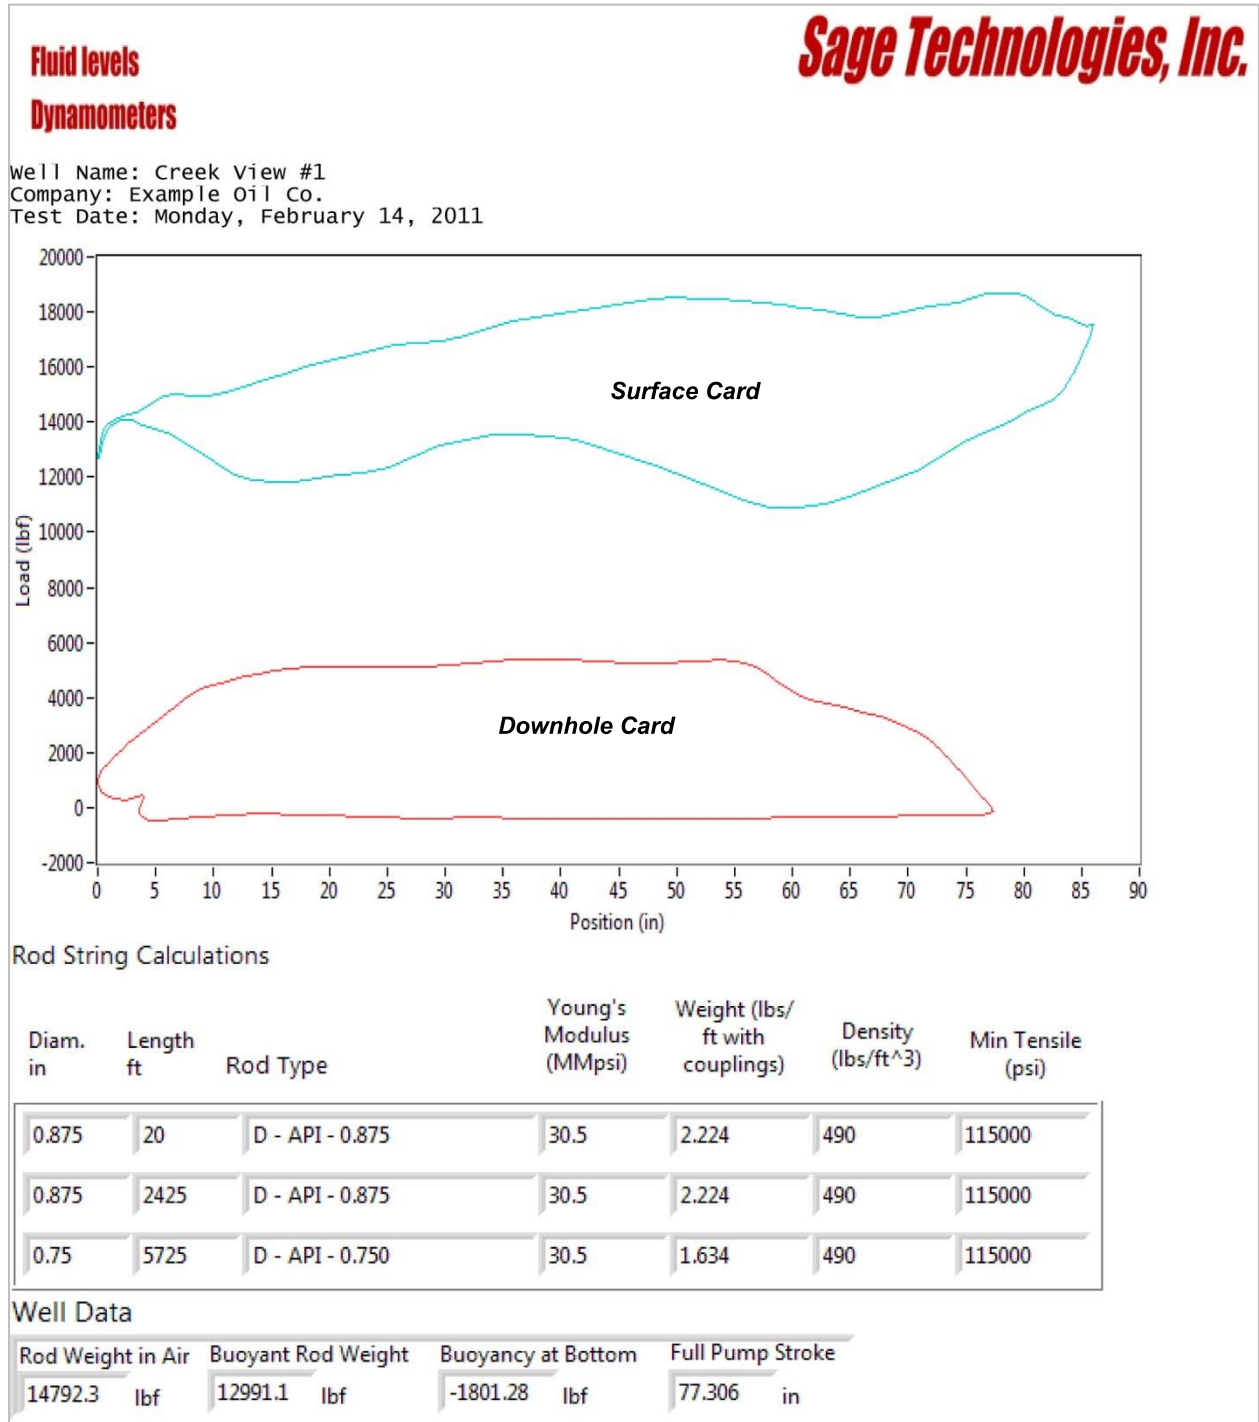
The downhole card shape as shown below indicates a worn plunger or worn traveling valve.

Even though new pump has been run during completion, it is evident that there has been damage. Pump is pulled and damage confirmed. Damage had been caused by inadequate clean-up after acid job.

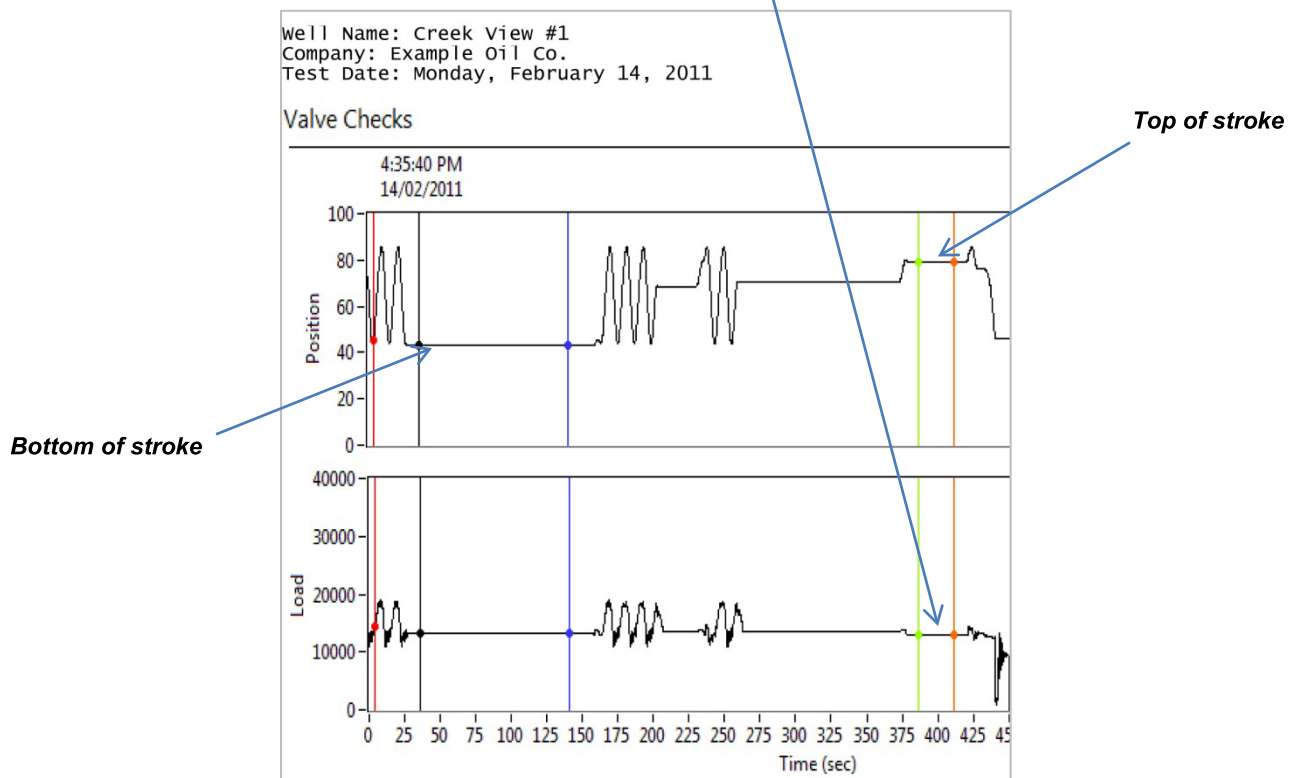
After identifying the appropriate downhole card shape, a valve check test is run to confirm valve problems. Valve check shows that no load is held on the **upstroke**, signaling a damaged traveling valve.
